Rehabilitation program of corals damaged by hurricane “Wilma” in October 2005, Isla Mujeres-Cancun National Park, Mexico.

JAIME GONZÁLEZ-CANO, ROBERTO IBARRA NAVARRO, ALEJANDRO VEGA ZEPEDA, JUAN CARLOS HUITRÓN BACA, and EDUARDO NÁJERA HILLMAN.

Comisión Nacional de Áreas Naturales Protegidas (CONANP). Venado No. 71, SM 20, Mz. 18 C. P. 77500. Cancún, Q. R. México.

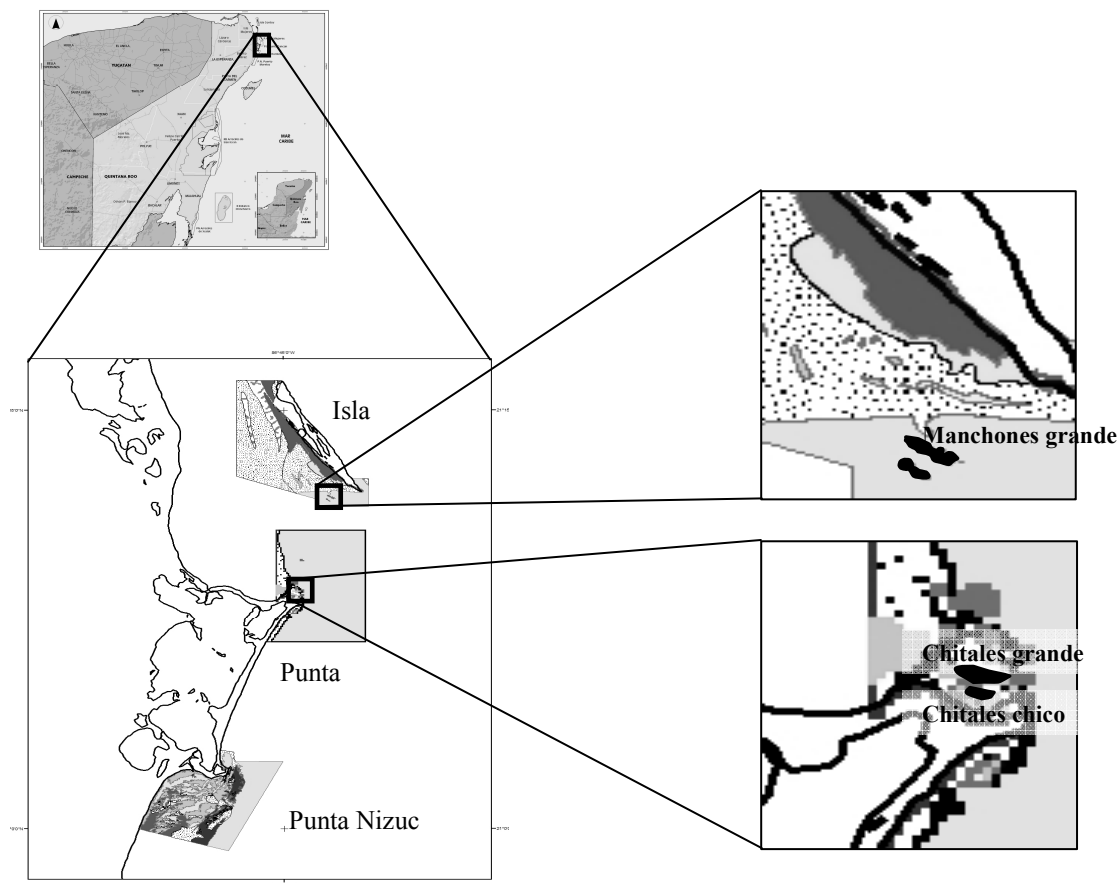
Figure 1. Polygon of the national park “Costa Occidental de Isla Mujeres, Punta Cancún y Punta Nizuc”. The more heavily damaged areas caused by “Wilma” hurricane are shown.
