Fish Fauna as Indicators of Coastal Restoration Goals

KATHLEEN SULLIVAN SEALEY and SHERRY CONSTANTINE
*College of the Bahamas Marine and Environmental Studies Institute,
University of Miami, P.O. Box 249118, Coral Gables, Florida 33124 USA*

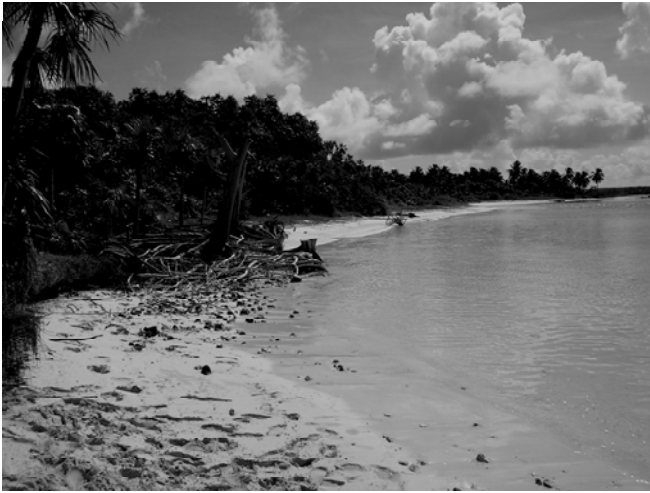
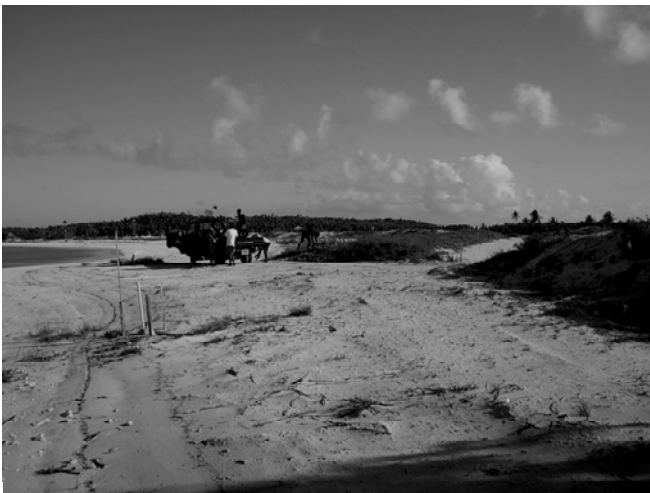
Figure 2. Photographs of WIND NORTH (upper) coastal site with intact coastal vegetation, and a shallow lagoon beach environment, and WIND SOUTH (lower) coastal site with a dredged basin, and wide un-vegetated shoreline.

To the north of the dredged coastal area, there are three other beaches with similar coastal geomorphology to the impacted site. These beaches are separated by small rocky headlands, and have varying amounts of fringing mangroves. One of these three beaches was chosen as the un-altered comparison site and was designated “WIND NORTH”. This beach is 1.5 kilometres north of WIND SOUTH and has near shore sea grass beds and sparse fringing mangroves. (shoreline pictures in Figure 2).
