Implementing nature-based solutions to climate change, by Guadeloupe Port Authority: the case of mangroves

CLEO BARON, AND SITA NARAYANAN

Guadeloupe Port Authority - Planning and Sustainable Development Department;

EXTENDED ABSTRACT

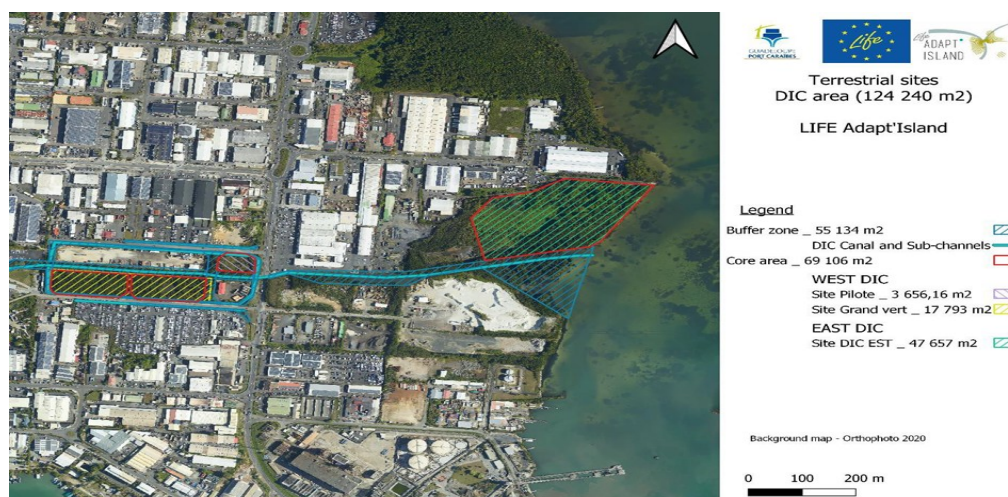
Figure 1. Selected restoration sites.

Two main sites have been selected (figure 1). Once the sites were selected, a clearing process was carried out to remove litter, including waste electrical and electronic equipment (WEEE) and vegetal invasive species. Physico-chemical analyses were conducted to assess pollution levels and soil contamination. These analyses identified pollutant types and concentrations, enabling the determination of appropriate treatments for their removal, disposal, or management.

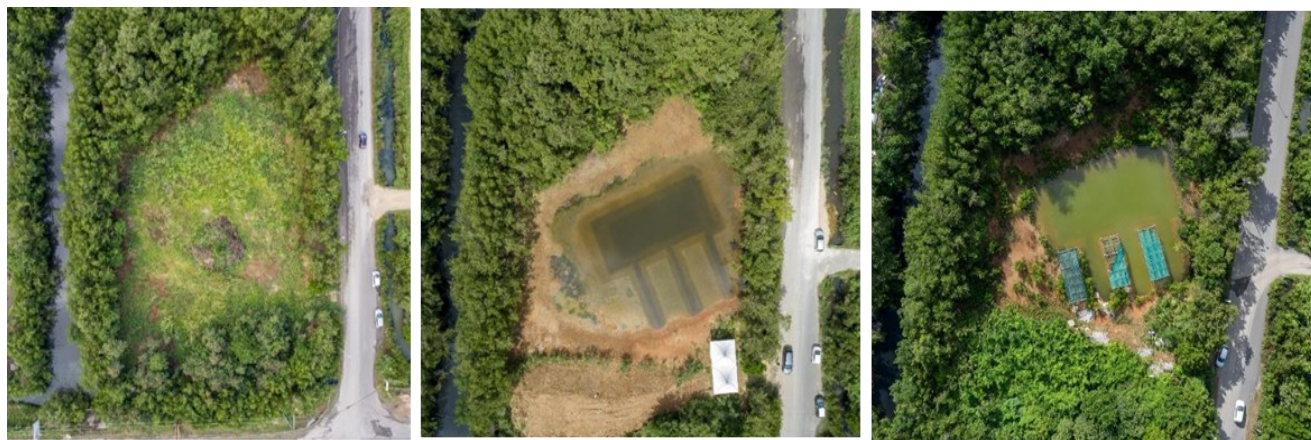
Figure 2. Evolution of the pilot site (2019-2022-2024).

2024. For the first monitoring campaign, all the plants selected for monitoring are alive. There was therefore no mortality among the control plants at T0. In addition to the planted mangroves, natural regeneration is occurring, particularly with white mangroves, which are sprouting in the area (Figure 2). This natural recovery highlights the ecosystem's resilience.
